SEISMIC STRENGTHENING OF BEAM-COLUMN JOINTS WITH MULTIDIRECTIONAL CFRP LAMINATES

Abstract

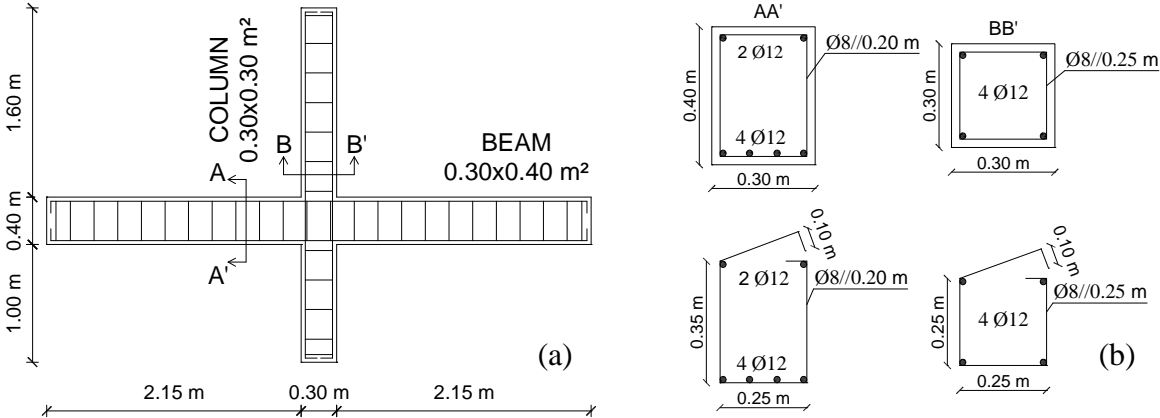
Figure 1 presents the geometry of the joints, as well as the detailing of the beam and column cross sections adopted for all the specimens. In the beams, with a cross section of 0.30 m wide and 0.40 m height, the longitudinal reinforcement was composed of 2 steel bars of 12 mm diameter (2Ø12) at the top and 4Ø12 at the bottom. The transverse reinforcement consists of 8 mm diameter stirrups spaced 0.20 m. In the columns, with square cross-section of 0.30 m edge, the longitudinal reinforcement was composed by 4Ø12 and the transverse reinforcement was formed by 8 mm diameter stirrups spaced 0.25 m. The concrete cover was 20 mm thick for the beams and columns of all elements.

Figure 1. Geometry and reinforcement detailing: (a) joint; (b) cross-sections of the beams and columns.

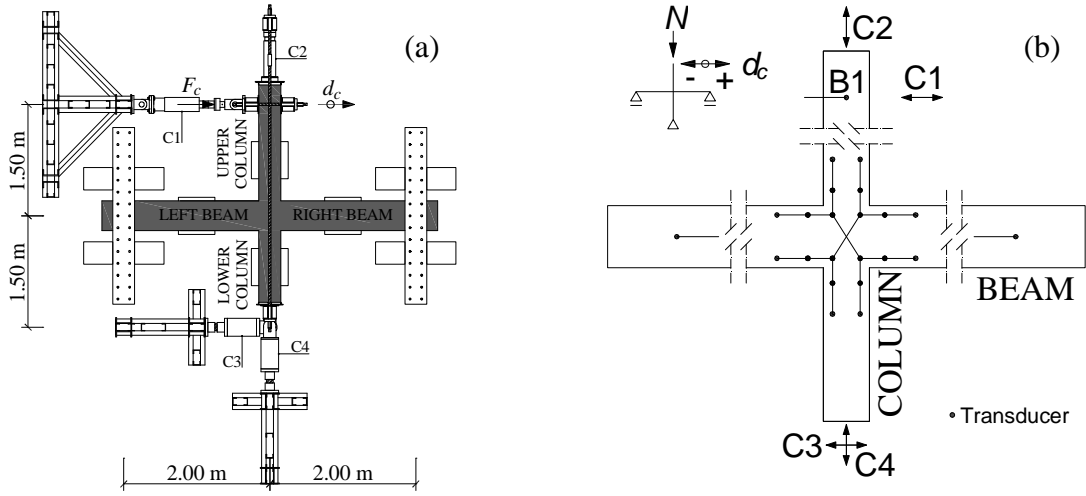
Figure 2 presents the adopted test setup and the instrumentation applied. The beams are

simple supported at their extremities, and the “lower” column is supported in both directions. The transverse and axial loads at the top of the “upper column” were applied by two hydraulic actuators equipped with two load cells C1 and C2 (see Figure 2b) to measure the corresponding forces. Additionally, one load cell (C3 in Figure 2b) was used to register the horizontal reaction at the base of the column and another one to register the vertical reaction at the same point (C4 in Figure 2b). Several inductive linear position sensors and linear variable differential transducers were used to measure relative displacements along the specimen. Further details about the test configuration and instrumentation can be found elsewhere [4, 5].

Figure 2. (a) Testing setup; (b) instrumentation.

All the tests were carried out under displacement control at B1 (see Figure 2b). The imposed law consisted on applying complete reversal cycles throughout eighteen displacement levels of increasing amplitude: ± 1 mm, ± 2 mm, ± 4 mm, ± 6 mm, ± 10 mm, ± 15 mm, ± 20 mm, ± 25 mm, ± 30 mm, ± 40 mm, ± 50 mm, ± 60 mm, ± 70 mm, ± 80 mm, ± 90 mm, ± 100 mm, ± 110 mm and ± 120 mm. From level ± 1 mm to ± 4 mm only one complete cycle per displacement level was performed. From level ± 6 mm to the end of the test three complete cycles per level were applied.

Figure 5 shows, for all the tested specimens, the global response in terms of lateral force (C1 – see Figure 2a) *versus* lateral displacement at the top of the column (B1 – see Figure 2b), as well as the corresponding envelopes. Table 1 presents the main results obtained in terms of maximum force reached and the corresponding displacement (in both directions) for the original (JD, JPA1 and JPA2) and strengthened (JDR, JPA1R and JPA2R) specimens.

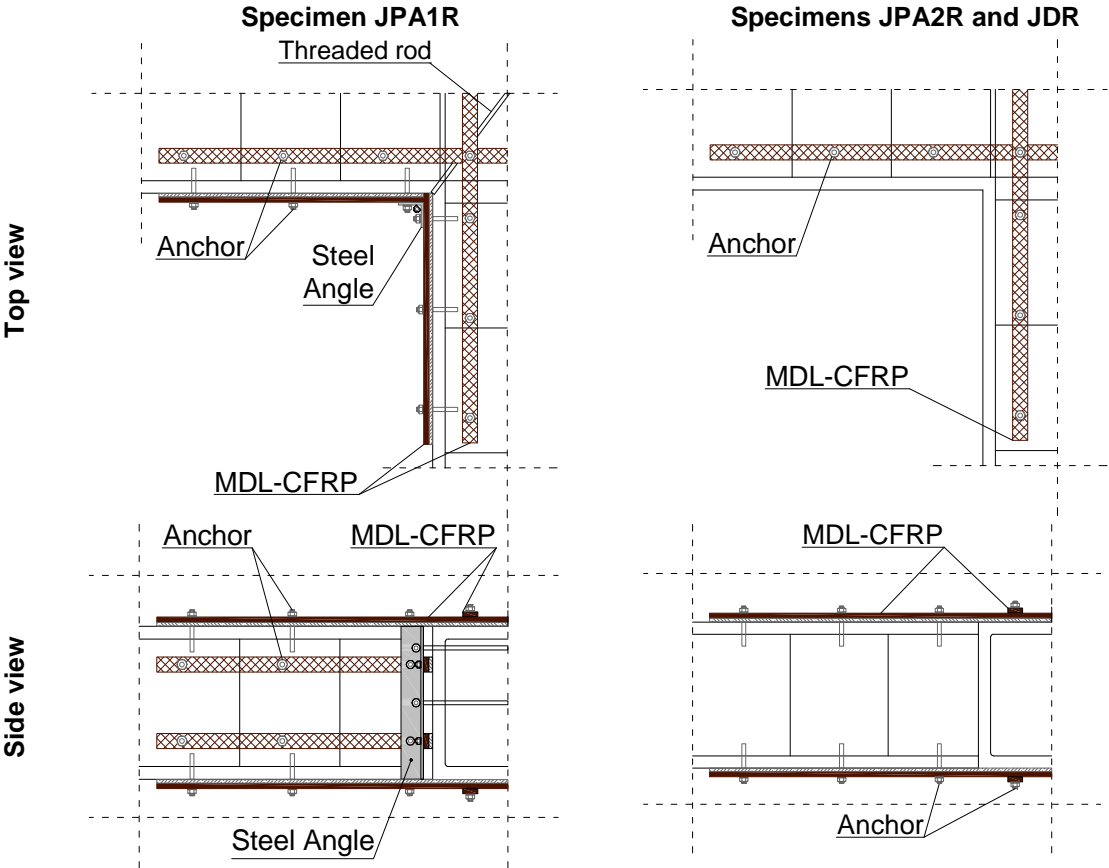
The experimental program was developed in two different phases. Initially, the three joints (denominated JD, JPA1 and JPA2) were submitted to a cyclic loading in order to introduce typical damages in these elements due to seismic actions. All the details about this testing phase can be found elsewhere [5]. In the second phase, all the joints were strengthened with MDL-CFRP according to the strengthening configurations and detailing represented in Figure 3. In this phase, the nomination adopted for the retrofitted joints is JDR, JPA1R and JPA2R.

Figure 3. Strengthening solutions detailing adopted in the context of the present work.

successive stiffness degradation is observed from the beginning of the test. The better performance of JPA1R is justified, by the threaded rods that avoid the concrete crushing at the corners of the joint and confine the core of the joint, and also by the strengthening strategy solution adopted for this specimen (see Figure 3).

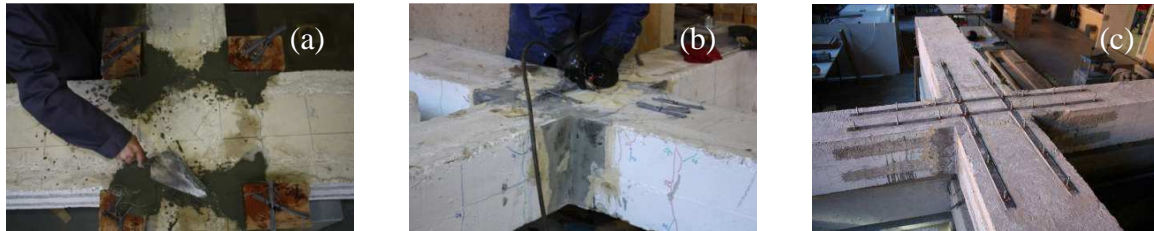
Repair and strengthening of the joints involved three main phases (see Figure 4): joint reconstruction with mortar, crack sealing with a chemical adhesive and MDL-CFRP application. All the details about these steps can be found in [3].

Figure 4. Specimens repair and strengthening: (a) joint reconstruction; (b) crack sealing; (c) MDL-CFRP application.

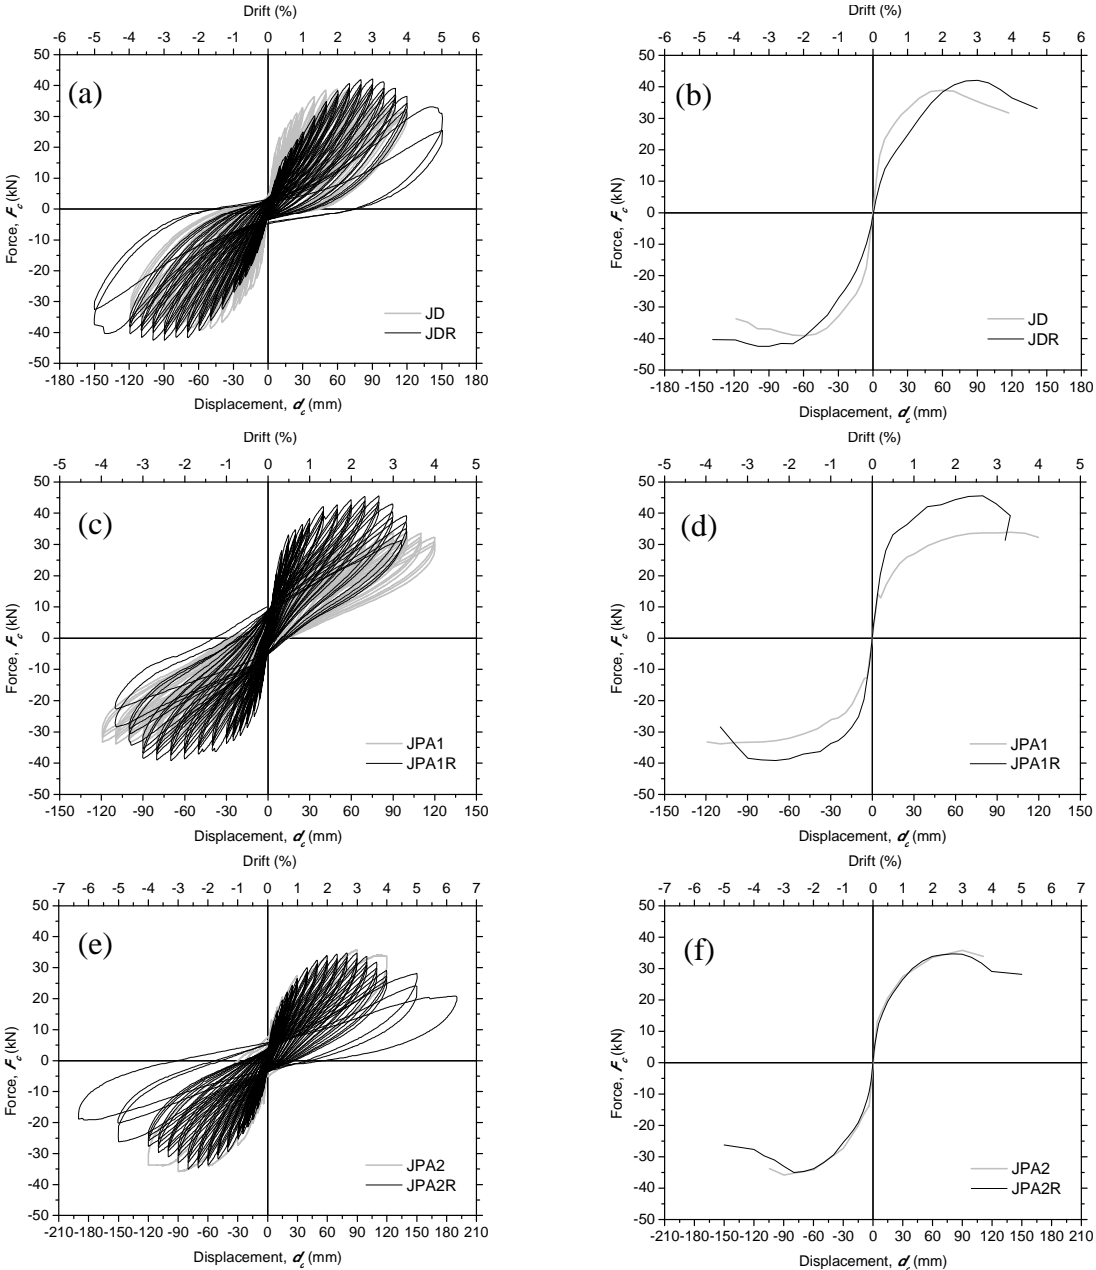
Figure 5. Force vs. displacement: (a) JD and JDR; (b) JD and JDR envelopes; (c) JPA1 and JPA1R; (d) JPA1 and JPA1R envelopes; (e) JPA2 and JPA2R; (f) JPA2 and JPA2R envelopes.

For JDR and JPA1R joints, the adopted repair/strengthening strategy provided an increase of load carrying capacity, when compared with the obtained for the corresponding original specimens (first phase). In fact, the load carrying capacity increase was about 10% and 35% for JDR and JPA1R specimens, respectively. The strengthening strategy applied in the damaged JPA2R specimen, restored the stiffness and the lateral force load capacity of the original JPA2 specimen, which is notable, considering the damage level previously installed.

Comparing the responses for the original and strengthened joints, in terms of force-drift envelopes, two distinct results can be observed. For JPA1R and JPA2R, the initial stiffness of the corresponding reference specimens was recovered, but not for JDR, which can be justified by the repairing solution adopted. In fact, for the specimens with plain rebars (JPA1R and JPA2R), apart from concrete spalling at the joint corners in the first phase of the tests, it was observed only a single large crack at the extremity of each beam and column element (JPA1 and JPA2). Thus, these damages were easily detected and repaired for these joints. However, for the specimen with ribbed rebars (JDR), in addition to the concrete crushing, several cracks with distinct widths occurred during the test of the first phase. In this case, the crack sealing strategy adopted was unable of restoring the integrity of the original joint.

the evolution of the stiffness degradation of the specimens for different drift levels. The secant stiffness was calculated for the maximum strength, positive and negative, for each half-cycle of the curves presented in Figure 5. This simplified procedure to evaluate the stiffness degradation evolution provides valuable information on the influence of the strengthening strategy on this phenomenon. As was expected, specimens JPA1R and JPA2R yielded better performance.

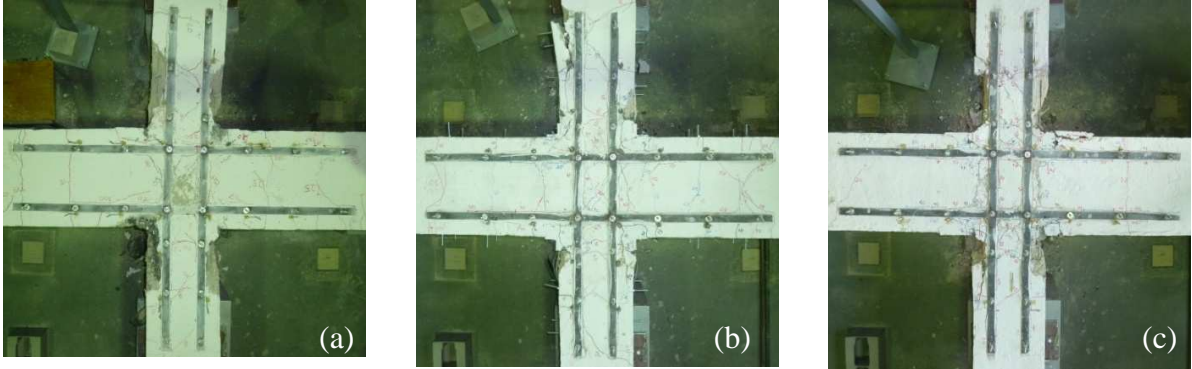
Figure 6 presents the failure modes of the joints, which were characterized basically by flexural cracks and concrete spalling at the corners of the joints. Comparing the damages for the tested strengthened joints, JPA2R presented the higher level of concrete spalling at the corners of the joint. This damage justifies the inferior performance of the strengthening strategy adopted in this specimen. On the other hand, the use of diagonal threaded rods (see also Figure 3) may have contributed for the delay of concrete spalling, justifying a better performance observed for specimen JPA1R.

Figure 6. Failure modes of the tested joints: (a) JDR; (b) JPA1R; (c) JPA2R.

Comparing the response of JDR and JPA2R joints in terms of loading carrying capacity, it is observed a better performance for the former. In fact, the location of concrete crushing of JPA2R specimen was closer to the corners of the joint, when compared to the obtained in JDR (see also Figure 6). This aspect is critical, since the flexural carrying capacity of a section is assured by the reinforcement under tension and the concrete under compression. Since premature concrete crushing of JPA2R was observed, an inferior performance is expected for this joint.

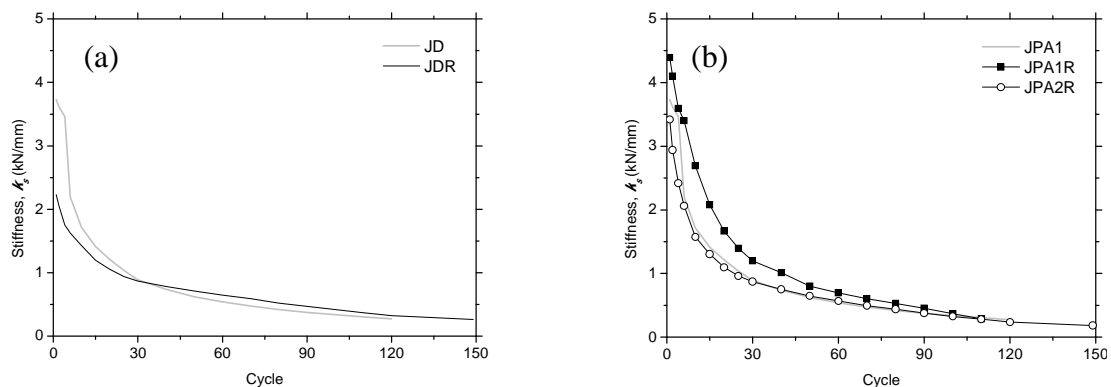
Figure 7. Stiffness degradation: (a) JD/JDR; (b) JPA1/JPA1R/JPA2R.
